<b>Subject:</b> <b>MULTI-MODEL - CONDENSATION / FOG IN FRONT AND REAR COMBINATION LIGHTS</b>	<b>Bulletin No:</b> 09-016/09
	<b>Last Issued:</b> 03/26/2009

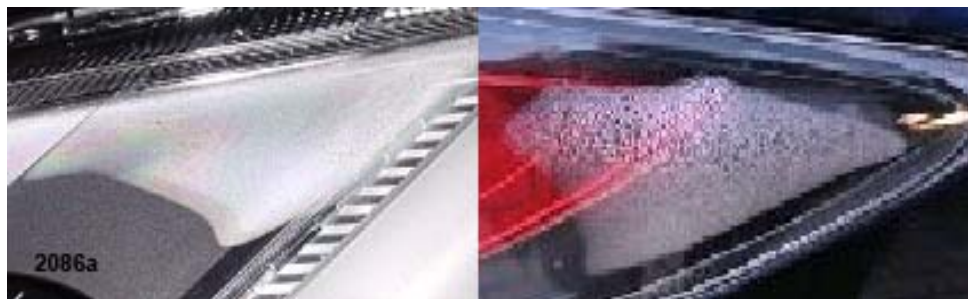
Some customers may complain of condensation / fog inside the front or rear combination lights. This condensation / fog is a natural phenomenon that occurs when there is a fairly large temperature difference between the inside and the outside of the light housing. Typically, it will clear during warmer ambient temperatures or when the lights have been on for some time.

**NOTE:** The recent new models have been fitted with a clear lens which can cause the symptom to be more noticeable, however, it does not affect the performance of the light.

Explain to the customer that this is a natural phenomenon and not a quality defect. DO NOT attempt repairs as this is considered normal.
