Subject: RATTLE NOISE FROM AUDIO SYSTEM WHEN DRIVING	Bulletin No: 09-038/09
	Last Issued: 07/22/2009

2006-2008 MX-5

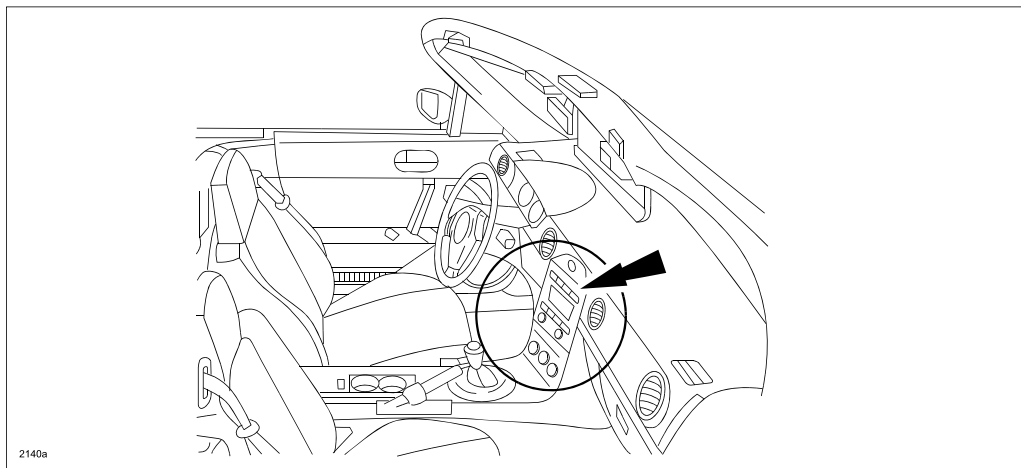
Some vehicles may exhibit a rattle noise from the audio system when driving the vehicle. Vibration from the audio brackets generate the rattle noise. The audio brackets have been modified to eliminate the noise.
