# Service Information

Category <b>S</b>	<b>Repair Guidance</b>	Ref. No. R033/11	Page 1 of 3
Coverage <input type="checkbox"/> Distributor only <input checked="" type="checkbox"/> Please inform your dealers		Date Issued May 13, 2011	
Please convey this information to your <input type="checkbox"/> Director <input checked="" type="checkbox"/> General Manager <input checked="" type="checkbox"/> Warranty Dept. <input checked="" type="checkbox"/> Parts Dept. <input checked="" type="checkbox"/> Training Dept. <input checked="" type="checkbox"/> Field Rep.		Date Revised	
Applicable Model  All models with leather seats	Applicable Countries or Specifications  Worldwide

## Subject: Wrinkles on Leather Seat Surface

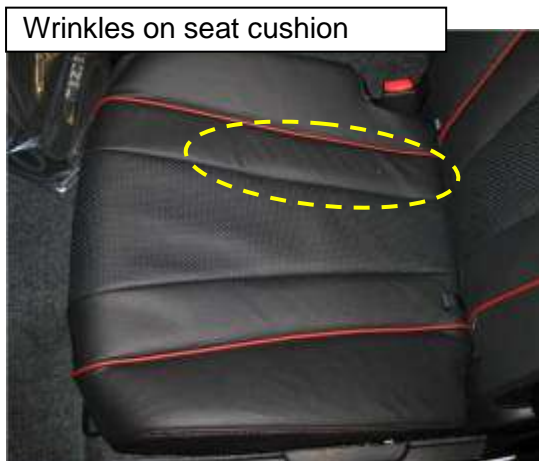
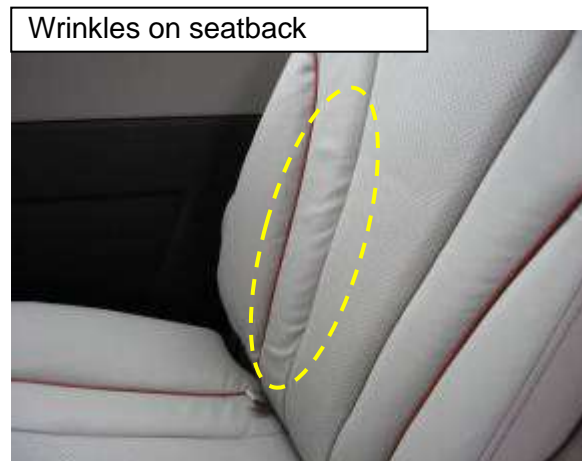
During PDI it may be found, or some customers may complain that some wrinkles occur on seat cushion and/or seatback surface.

Seat surface material is stretched.

When you encounter this concern, remove the wrinkles on the seat surface as per following procedure.

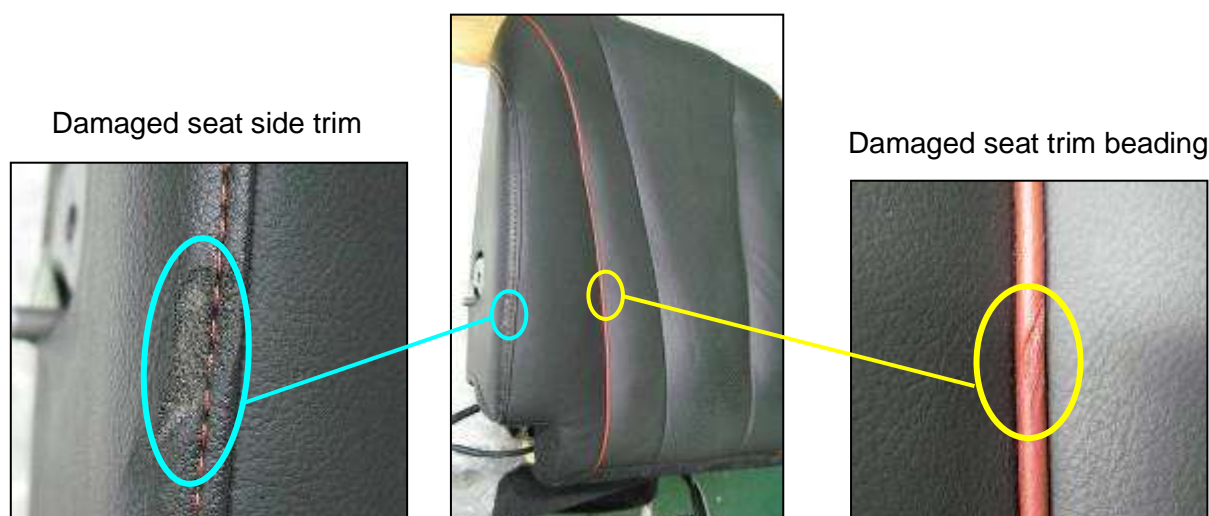
**Caution: Do NOT keep the iron at the same place for a long time / run the iron without a water-soaked cloth especially over seat trim beading and seat side trim area. Failure to do so may damage the seat surface as shown below.**
