# Service Information

Category <b>T</b>	<b>Repair Guidance</b>	Ref. No. R087/17	Page 1 of 3
Coverage <input type="checkbox"/> Distributor only <input checked="" type="checkbox"/> Please inform your dealers		Date Issued December 26, 2017	
Please convey this information to your <input type="checkbox"/> Director <input checked="" type="checkbox"/> General Manager <input checked="" type="checkbox"/> Warranty Dept. <input checked="" type="checkbox"/> Parts Dept. <input checked="" type="checkbox"/> Training Dept. <input checked="" type="checkbox"/> Field Rep.		Date Revised	
Applicable Model  MX-5 (ND) with Retractable Fastback	Applicable Countries and/or Vehicle Specifications  Worldwide

## Subject: Engine will not start due to Battery being discharged

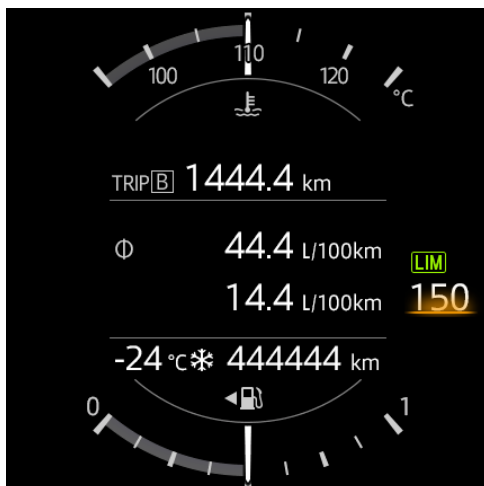
Due to a software error of the speedometer of type A instrument cluster, a dark current of 80 mA continues to flow after the ignition is turned off in the conditions listed below. Thereby, if the vehicle is not used for many days and left in this condition, the battery is discharged.  
**NOTE:** A normal dark current value is about 25 – 45 mA.

While Auto Cruise Control (ACC) or Adjustable Speed Limiter (ASL) is being operated or activated (when one of the ACC/ASL indicators is ON in MID as shown in figure), the ignition is switched off.

1. Confirm with the customer the situation when the problem occurred asking if:
  - The ignition was turned off while ACC or ASL was operating.
  - The vehicle was left in this condition and not used for many days.
2. Explain to the customer the following:
  - There will be a software update for instrument cluster available in the near future to solve this concern.
  - For the time being, to avoid further occurrence of this case, please always switch off ACC or ASL before IGN OFF.
3. If the customer insists on an immediate repair, replace the speedometer (instrument cluster) with a modified one according to the workshop manual "INSTRUMENT CLUSTER REMOVAL/INSTALLATION".

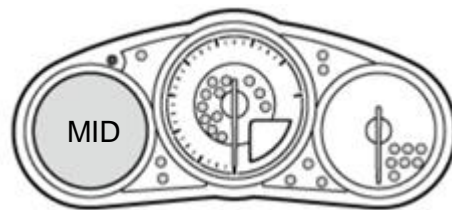
-Instrument Cluster with MID-

One of indicators is ON.

If the above condition is set, the microcomputer is not shifted into the sleep mode and the operation current of 80 mA continues flowing. If the ignition is switched off after ACC or ASL is turned off, this concern does not occur.
